**Investigation of the  
Helios Prototype Aircraft Mishap**

**Volume I  
Mishap Report**

**January 2004**

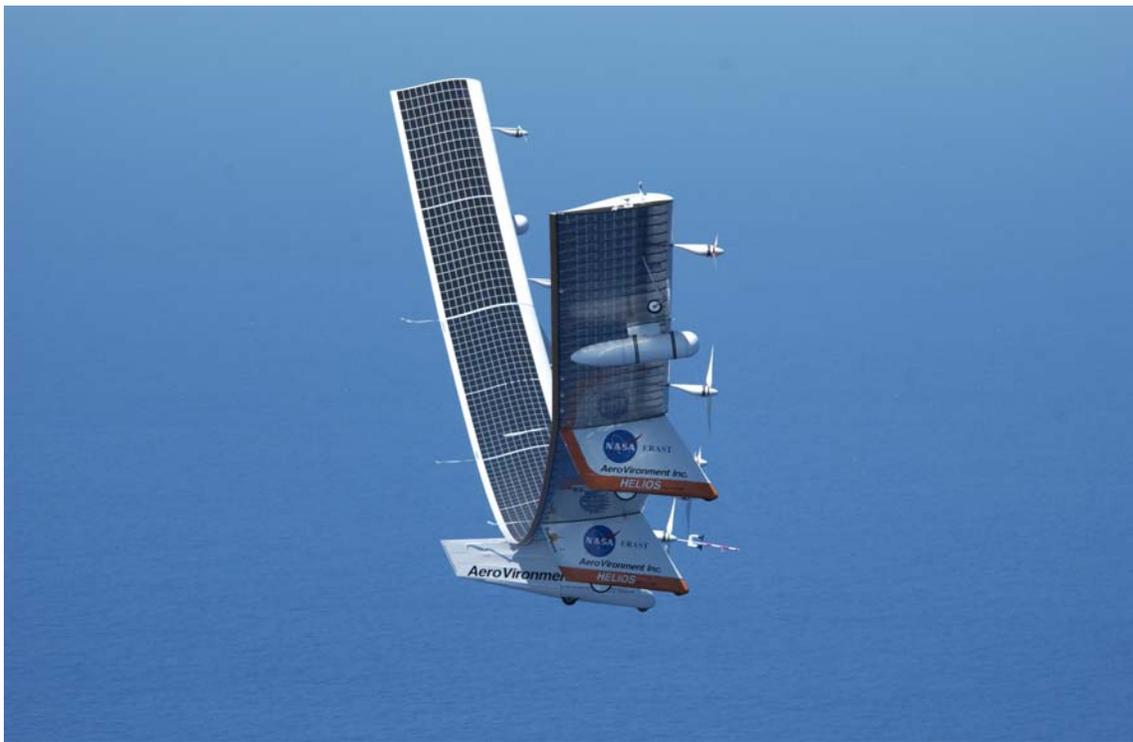
**Figure 7.4 - HP03-2 at High Wing Dihedral**

The SP had selected the wing-tip video camera to observe the aircraft because he believed it would give the best indication of wing dihedral and also how the aircraft was responding to any turbulence. At 10:35am, at approximately 2,800 feet altitude as defined by the Global Positioning System (GPS), the aircraft began experiencing airspeed excursions of around  $\pm 2$  ft/sec. At this time the wing-tip video indicated that the dihedral seemed high for the speed the aircraft was flying. When looking at the video, the camera view essentially pointed at the top of the center of the aircraft rather than the more usual view looking across the wingspan. The high dihedral persisted (Figure 7.4), and a pitch oscillation built up, similar to what had previously occurred but not observed and thus had not been interpreted as a potentially dangerous periodic oscillation. The SP noted that he was continuing to see large wing dihedrals and asked the Stability and Control Engineer (S&CE) to confirm that the correct procedure to reduce dihedral was to increase airspeed. The S&CE concurred, and at 10:35:12am the SP selected an increase in airspeed of 1ft/sec (37 ft/sec to 38 ft/sec). The dihedral decreased slightly then grew past 30 feet.

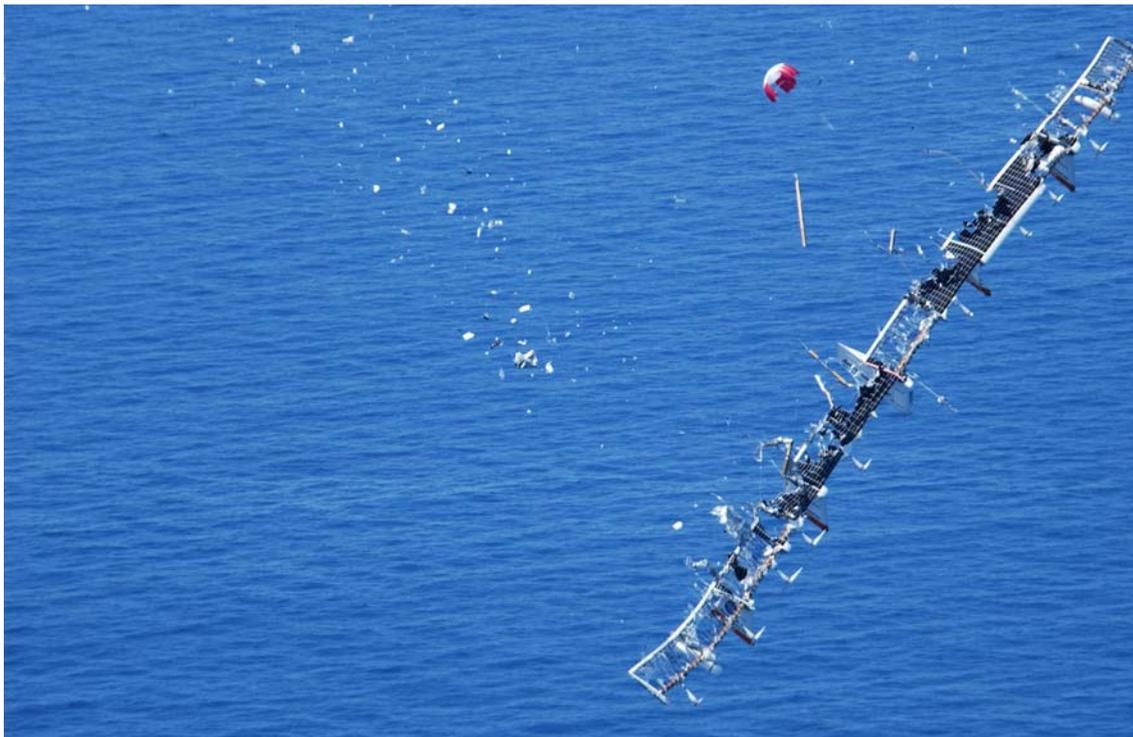
**Figure 7.5 – HP03-2 Falling Towards the Pacific Ocean**

At 10:36:28am at these extreme conditions, the aerodynamic loads broke the leading edge foam sections of the right wing near the hydrogen fuel tanks and then began ripping the solar cells and skin off the upper surface of the wing. The wing-tip video continued to function for a few more seconds and showed other portions of the aircraft starting to tear away as the aircraft continued to destruct. The last video frames show the wing sweeping aft. This could be due to the fuel cell weight at the aircraft centerline and increased drag outboard due to loss of the skin. Figure 7.5 shows a photograph of the aircraft as it is falling towards the ocean.

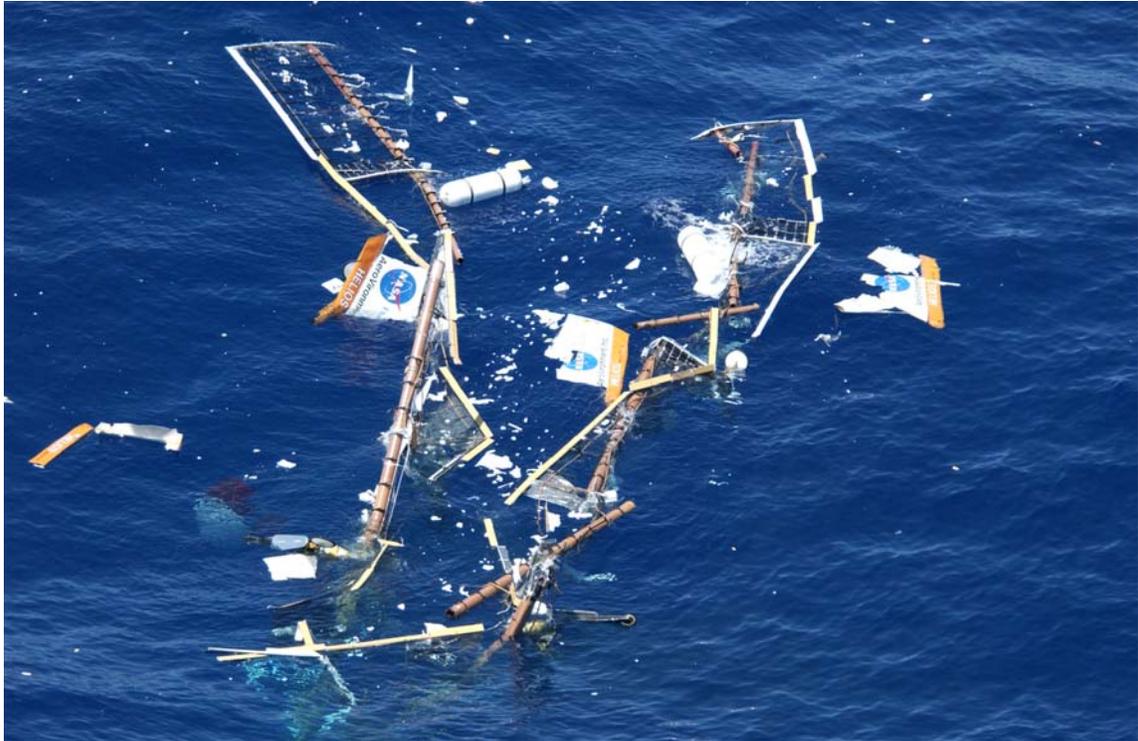
**Figure 7.6 – HP03-2 upon Impact with the Ocean**

At 10:37am, the aircraft impacted the ocean in mile-deep water 10 miles off the coast of Kauai, where, upon impact, the structure including the main load carrying composite wing spars were severely damaged (Figure 7.6). The elapsed time from the first effort to diagnose and correct the high wing dihedral condition to the point at which the airplane began to break up in the air was 91 seconds. Figure 7.7 provides time histories of the aircraft's pitch rate and airspeed, and the wing dihedral for the 30-minute flight.

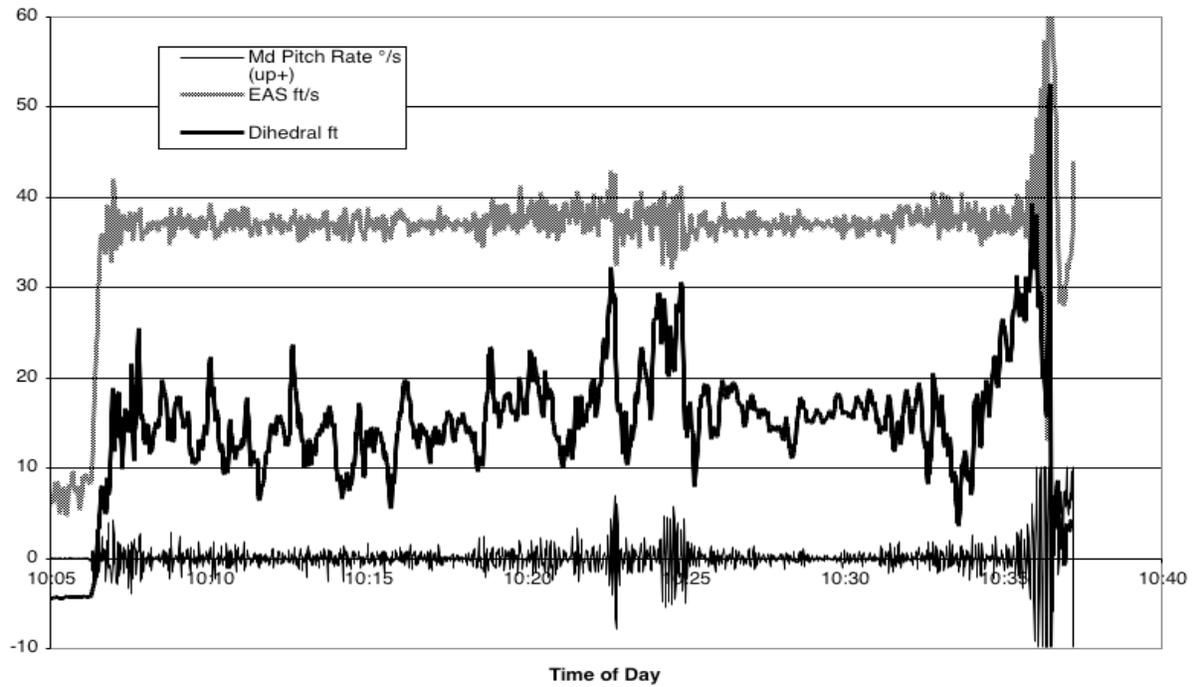
**Figure 7.7 – Wing Dihedral, Pitch Rate, and Airspeed History for Flight HP03-2**

- For the HP03-2 flight, it was surprising just how strong the dihedral response to turbulence was compared to the HP03-1 flight on 7 June 2003. In the smooth air (an unusual condition for the area) observed on 7 June 2003 the aircraft dihedral shape was well predicted, as mentioned above, and within acceptable levels. On 26 June 2003 the trade winds veered slightly more southerly than the typical east-northeast direction. In addition, the shear lines from the island's wake boundaries were converging near the aircraft. These weather conditions created a stronger gust environment than 7 June. Under these conditions, the aircraft assumed large dihedral deflections (first two events), sustained them for tens of seconds, and then abruptly returned to normal, all for no apparent reason.

- It was also observed that the aircraft dihedral shape in turbulence was not robust, that is, the aircraft was slow to restore to a more classical and stable shape. Although analyses performed before the mishap flight showed this fact, the first flight on 7 June appeared to confirm that the less robust configuration could be made acceptable with appropriate control system gain changes. This may have been false confidence in that flight HP03-1 was flown in one of the most benign turbulence conditions encountered during solar-aircraft flights from PMRF.

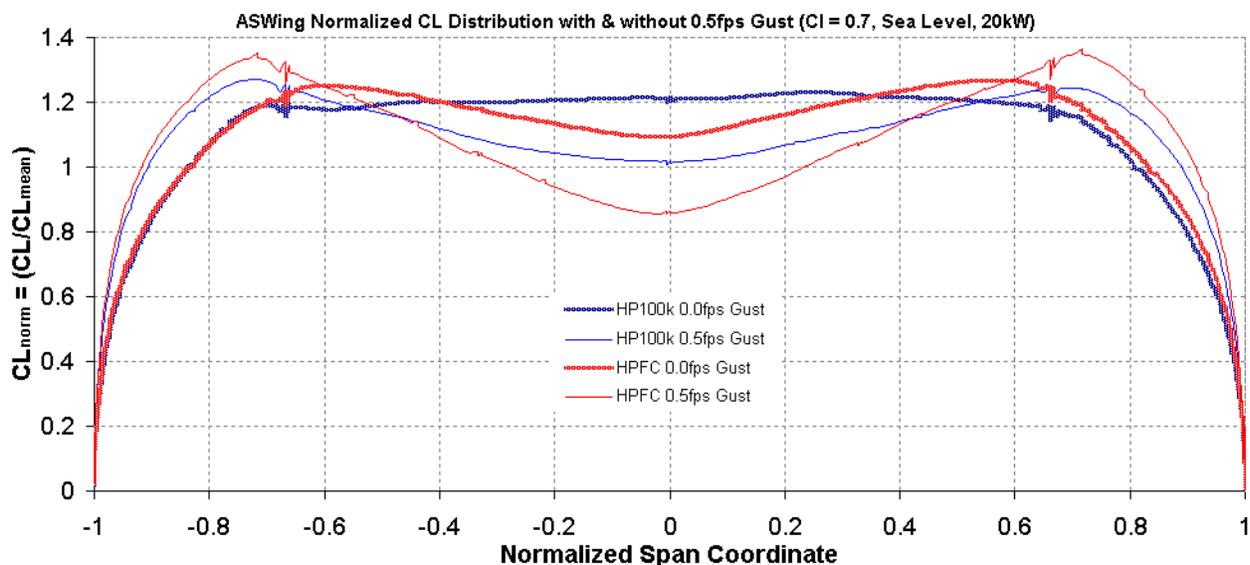
**Figure 9.3 – Variation Spanwise Lift Distribution with Gust Velocity**

Figure 9.3 provides a comparison of the wing spanwise lift distribution for the HP01 and HP03-2 aircraft configurations with a superimposed 0.5 ft/sec gust. For this study, it was assumed that the aircraft encountered a gust exhibiting a 0.5 ft/sec downward flow at the centerline and 0.5 ft/sec upward flow at the wing tips. Although the probability of the aircraft encountering such a gust is very low, the intent of the analysis was to show the sensitivity of the aircraft to gusts, even small gusts. The HP03-2 configuration has noticeably more lift outboard and less lift inboard. The increased lift outboard would be expected to lead to considerably increased dihedral. It is important to remember that the modeled sensitivity to local variations in sectional airflow is primarily a consequence of the aircraft's reactions to increasing dihedral, trailing edge up elevator, and wing tip leading edge twisting up, not the first-order effects of airflow change. The airflow variation is only the transitory force. The elevator response and the change in twist are what make the wing slow to return to nominal dihedral conditions. Document #26 found in Volume III, Appendix E provides a detailed discussion of this finding. In the absence of a gust that flattens the wing (for example, a momentary gust having relative downward air motion on the tips and upward near the airplane centerline), these aerodynamic effects slowed the return to nominal dihedral.

Although general weather conditions seemed to be within the bounds present during previous PMRF flights, HP03-2's faster air speed and unchanged climb rate led to a different flight profile with greater exposure to the turbulence. As a result, HP03-2 flew a greater distance at low altitudes and thus was exposed to the turbulent patterns induced by Kauai for a longer period of time. Also, the HP03-2 encountered the shear lines at a lower altitude than previously, closer to the shear lines' regions of maximum turbulence.

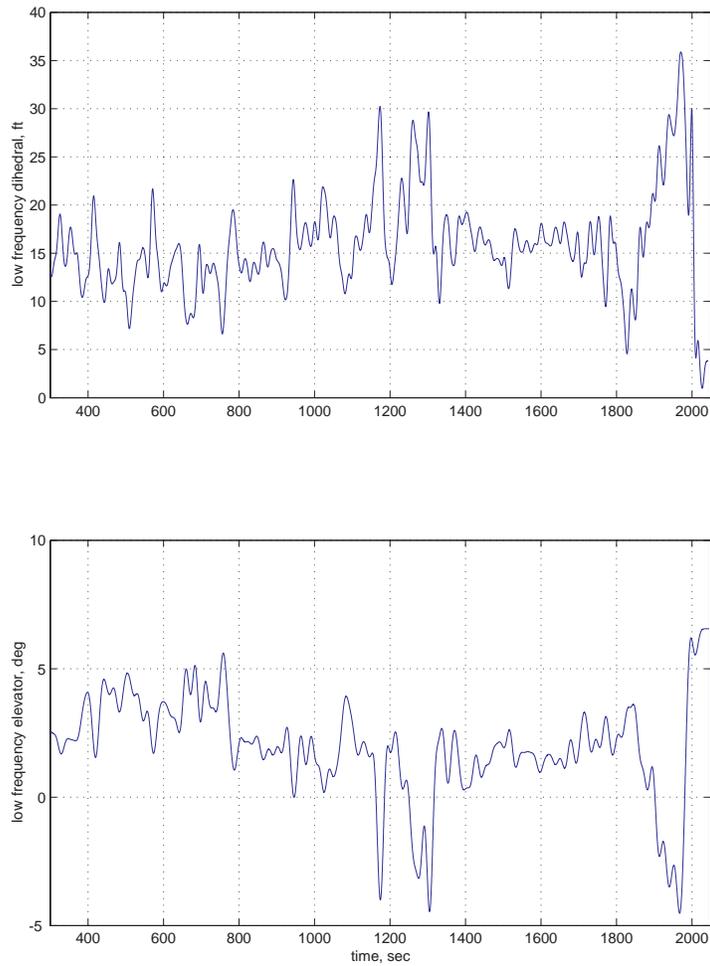
**Figure 9.4 – Time History of Wing Dihedral and Elevator Position**

Also through video interpretation, separated airflow on the center wing section did not contribute to the persistent high dihedral. The spanwise redistribution of lift from the center of the aircraft to the outboard panels caused by the loss of lift in the center panel is reinforced by the wing tips twisting leading edge up as dihedral increases. The primary cause of dihedral-induced twisting of the wing tip leading edges is the relatively forward center of gravity and the elastic axis of the wing being above the chord line of the wing. This interrelationship forces the wing to twist leading edge up as the tips bend up. Figure 9.4 provides time histories of the wing dihedral and the elevator position.

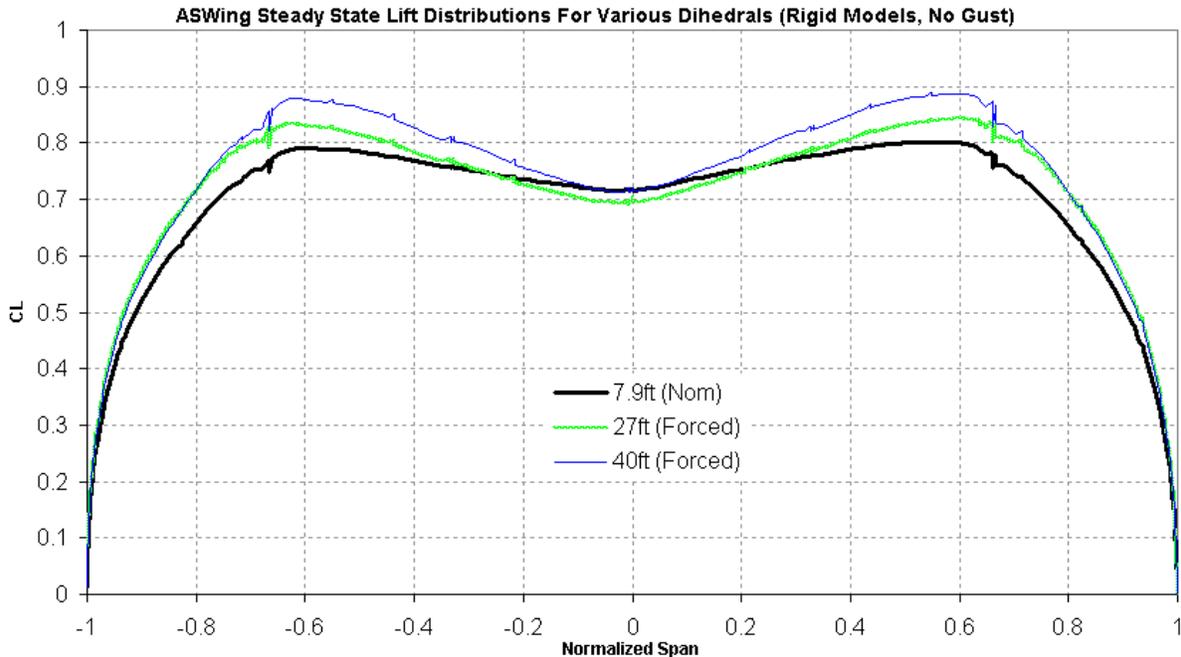
**Figure 9.5 – Spanwise Lift Distribution for Various Wing Dihedral**

The quantification of the primary effects of dihedral on elevator position and twist is best illustrated by analyzing the spanwise lift distribution. For a given airspeed and motor power setting, the predicted spanwise distribution of lift is provided in Figure 9.5. The spanwise redistribution of lift from the center of the aircraft to more outboard panels is the primary cause of the unexpectedly slow return to lower dihedral after any perturbation.

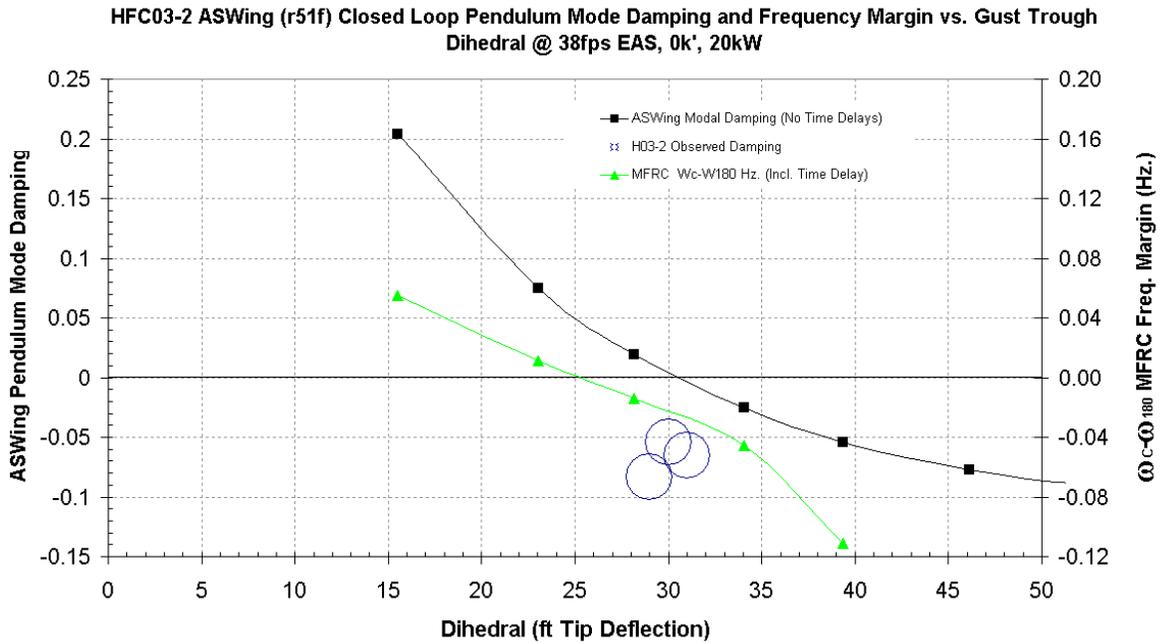
**Figure 9.6 - ASWing Predicted Phugoid Mode Damping for Steady State Flight at 38 ft/sec**

It is concluded that the persistent high dihedral caused the pitch instability. The pitch oscillation shares many characteristics with a traditional neutrally damped phugoid response of conventional fixed wing aircraft. For the Helios, the period of the neutrally damped pitch oscillation was about 8 to 9 seconds and the pitch rate was about 5 degrees/second. The stability of the oscillation was predicted and observed to be proportional to the wing dihedral of the aircraft. For wing dihedrals of about 30 feet wing tip deflection, the pitch oscillation became dynamically unstable. The predictions of the ASWing and Matlab codes, and flight estimates are shown in Figure 9.6.

The Matlab predictions, which included time delays determined during the flight test, agreed better with the flight observations. Although both models predicted more stability than observed in flight, they clearly capture the instability. The difference between predicted and observed neutral damping is not considered significant because the differences are about the same as the uncertainty of estimating wing tip deflection from strain gauge measurements. Clearly, the light to neutrally damped oscillations observed in an event 5 to 6 minutes before the crash corroborates these predictions. Figure 9.7 and Figure 9.8 graphically captures the damping estimates represented by two of the blue circles (first encounter or event involving the unstable mode and the mishap event) in Figure 9.6.

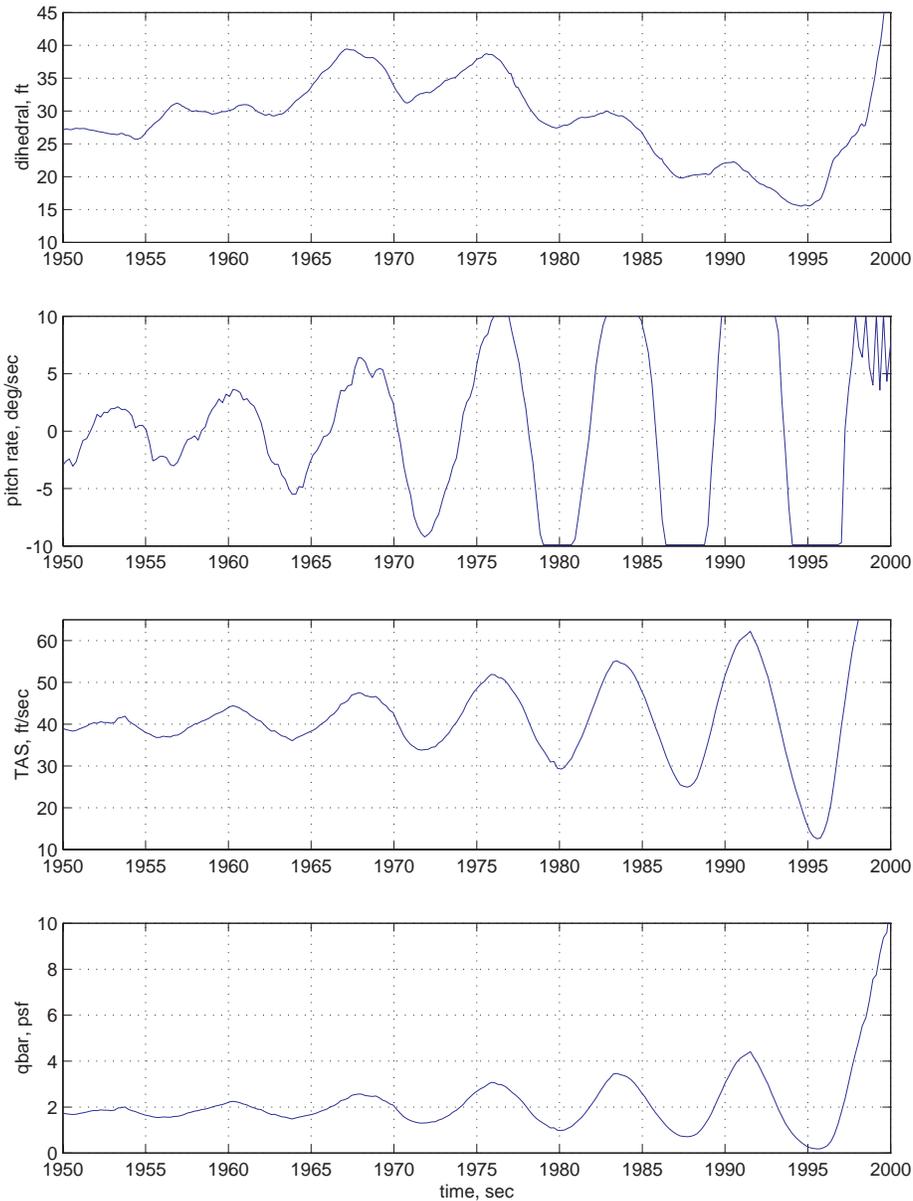
**Figure 9.8 - Dihedral, Pitch, Vehicle Airspeed, and Dynamic Pressure for Mishap Event**

At the large dihedrals, what may resemble a conventional neutrally damped, phugoid of a conventional aircraft is probably more accurately characterized as a dynamically unstable pendulum mode. The mode increases pitch attitude excursions, and increases airspeed with each nose down cycle despite apparent reductions in dihedral below the approximate 30-foot stability threshold. Those airspeed excursions quickly exceeded the maximum dynamic pressure design limit and resulted in the solar cell skin failures and subsequent loss of aircraft. The large wing tip deflections and more important, the persistence of dihedral was the physical cause of aircraft loss. Understanding the unanticipated large and persistent dihedral was a primary focus of post flight analytical analysis. The rapidly increasing airspeed excursions with each nose down pitch are obvious in Figure 9.8, the mishap event time history.

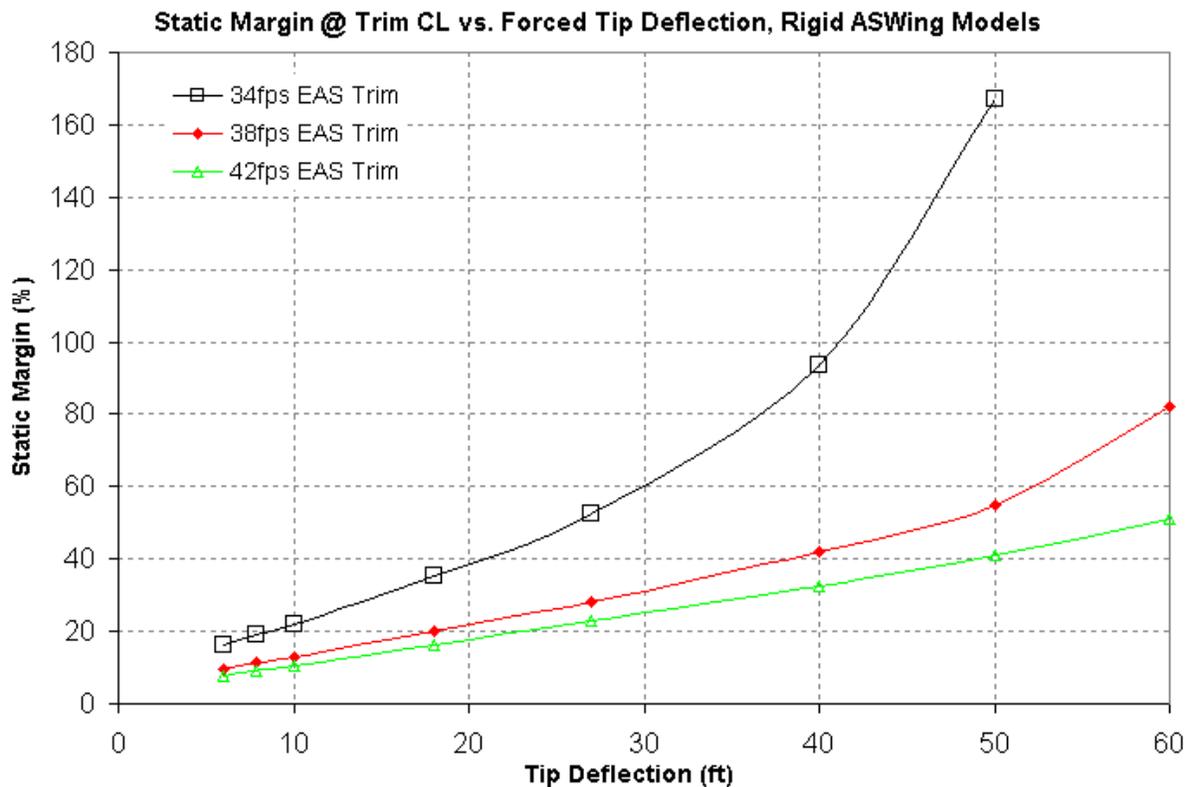
**Figure 9.9 – Static Margin Versus Aircraft Stability with Increasing Airspeed**

The underlying physics of the phugoid mode and its potential instability is thought to be a consequence of two primary factors. First, large longitudinal static stability that arises from a high aerodynamic pressure relative to center of mass as the wing tips bend up. As the dihedral increases, the center of aerodynamic force moves further above the center of gravity. The growth in static margin with increasing dihedral is shown in Figure 9.9. This increasing static stability is believed to increase phugoid instability.

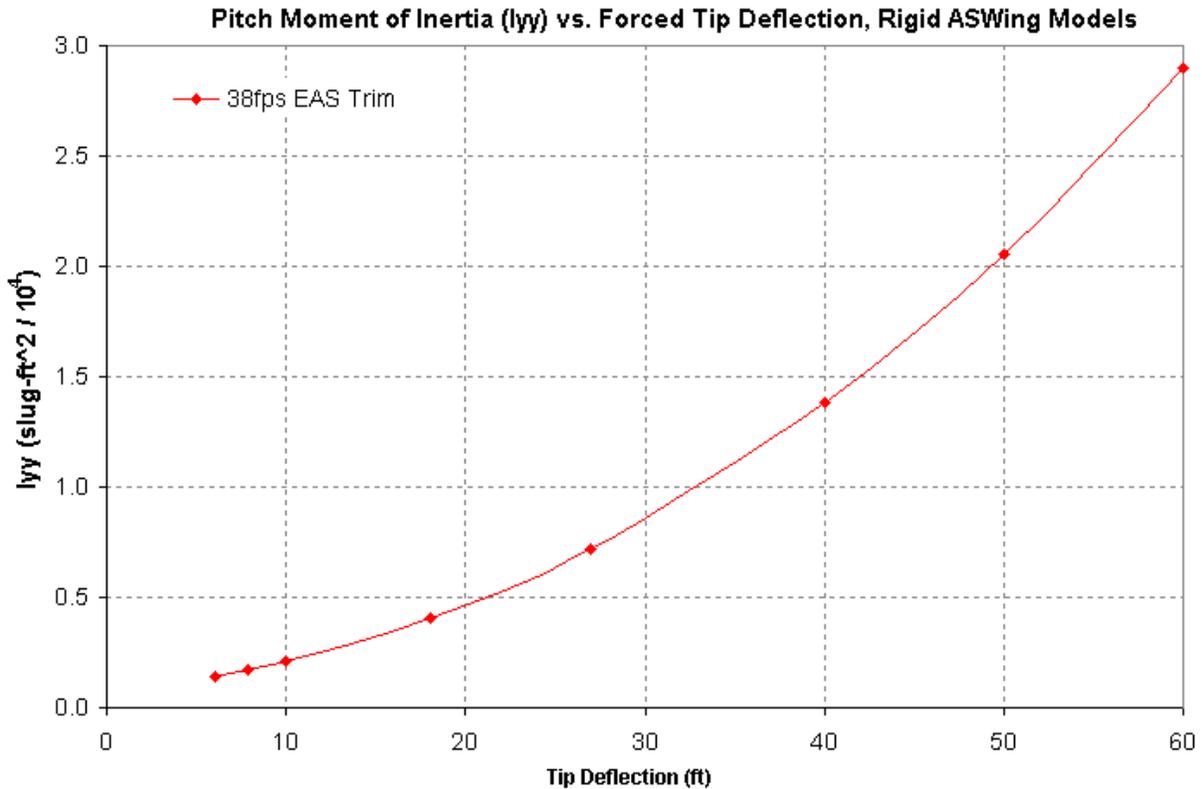
**Figure 9.10 - Aircraft Pitch Inertia Versus Wing Dihedral at 38 ft/sec**

The second factor is the pitching inertia of the aircraft which increases dramatically while the restoring aerodynamic forces grow much slower. Although the dynamics of the HP03-2 pitch oscillation while in forward lifting flight are quite complex, a dominant force is the pitching inertia, which grew by a factor of five over the dihedral range seen on the HP03-2 flight. Figure 9.10 graphically relates the variation of pitch inertia with dihedral.
