**Investigation of the  
Helios Prototype Aircraft Mishap**

**Volume I  
Mishap Report**

**January 2004**

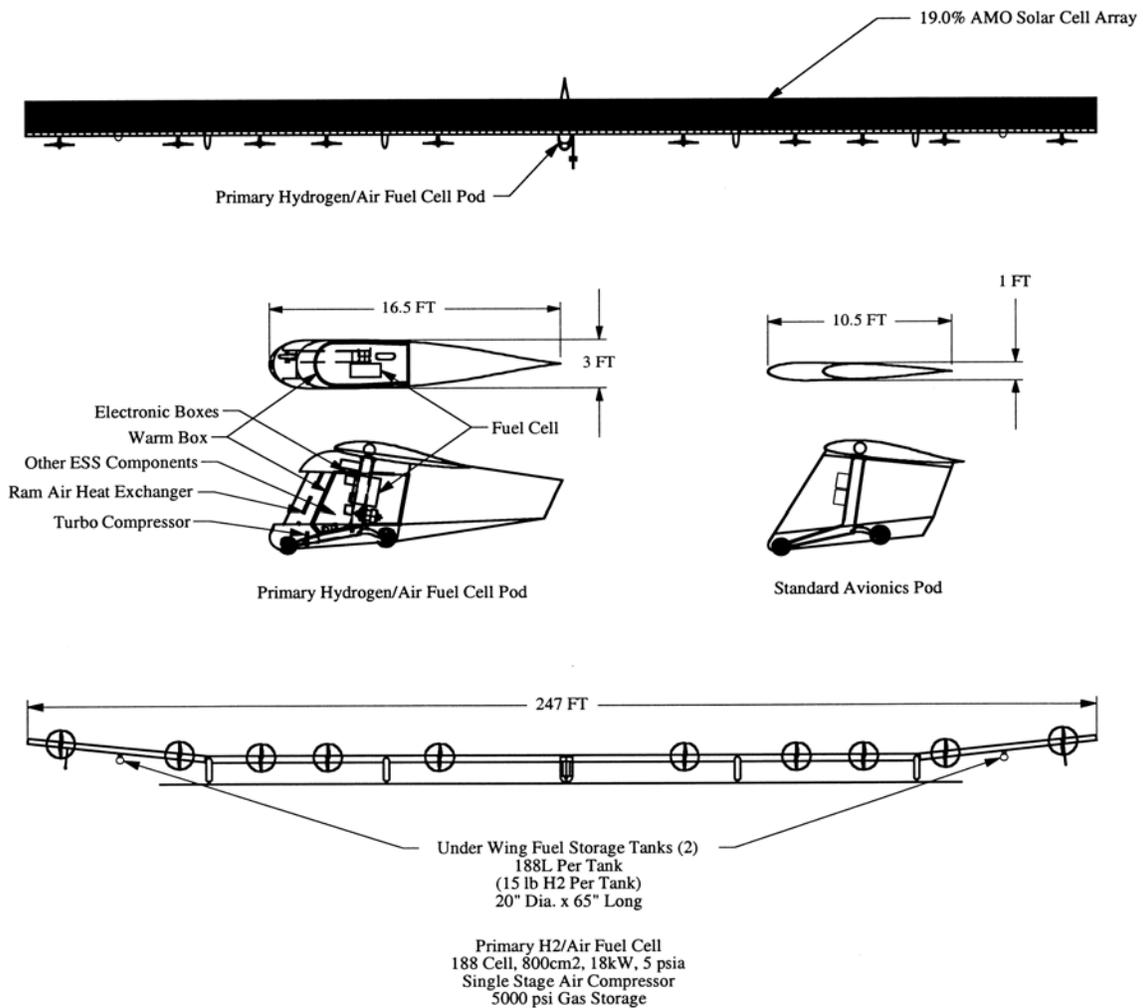
**Figure 6.5 - Schematic of HP03 Hydrogen-Air Fuel Cell Configuration**

NASA and AV also recognized that the structural, stability and control, and aeroelastic margins of safety were less on the HP03 than on the HP01. However, these margins were still sufficient to conduct the 2003 long endurance flight demonstration. It was also recognized that the mass distribution for HP03 was significantly different than the mass distribution of the initially proposed demonstrator with a RFCS system. The aircraft with the RFCS would have required only two regenerative fuel cell pods located at about 1/3 the distance from the vehicle centerline to the wing tip. The aircraft with the PFCS installed was more point loaded in that 3 pods were required. The heavy primary hydrogen-air fuel cell pod (520 lbs) was located at the centerline of the aircraft and the 2 high-pressure hydrogen fuel tanks (165 lbs each) were located at the center of each wing tip panel. A schematic of the PFCS is provided in Figure 6.5.

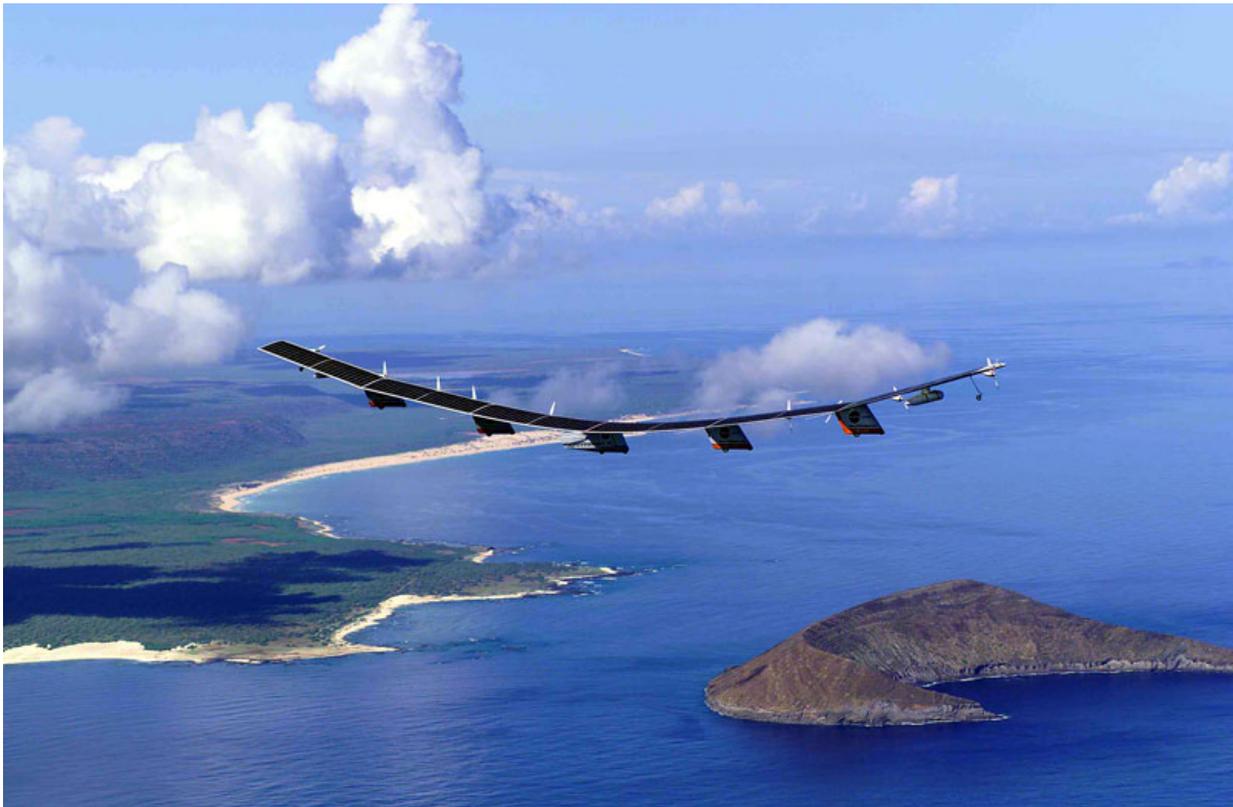
**Figure 6.6 - HP03-1 Flight on 7 June 2003**

The flight performance predictions estimated that the HP03 was capable of approximately 30-hour flight duration at 50,000 ft altitude. During the flight, data were measured in real-time to validate the predicted aeroelastic characteristics of the aircraft and to demonstrate that the vehicle was aeroelastically stable at the flight conditions expected for the long-endurance flight demonstration. The aircraft flew flawlessly thus validating the handling and aeroelastic stability of the aircraft in smooth air. However, the flight was aborted about 15 hours after takeoff because of some leakage associated with the coolant system and compressed air lines that feed the PFCS. Because of this leakage, the test team was unable to start-up the fuel cell system.

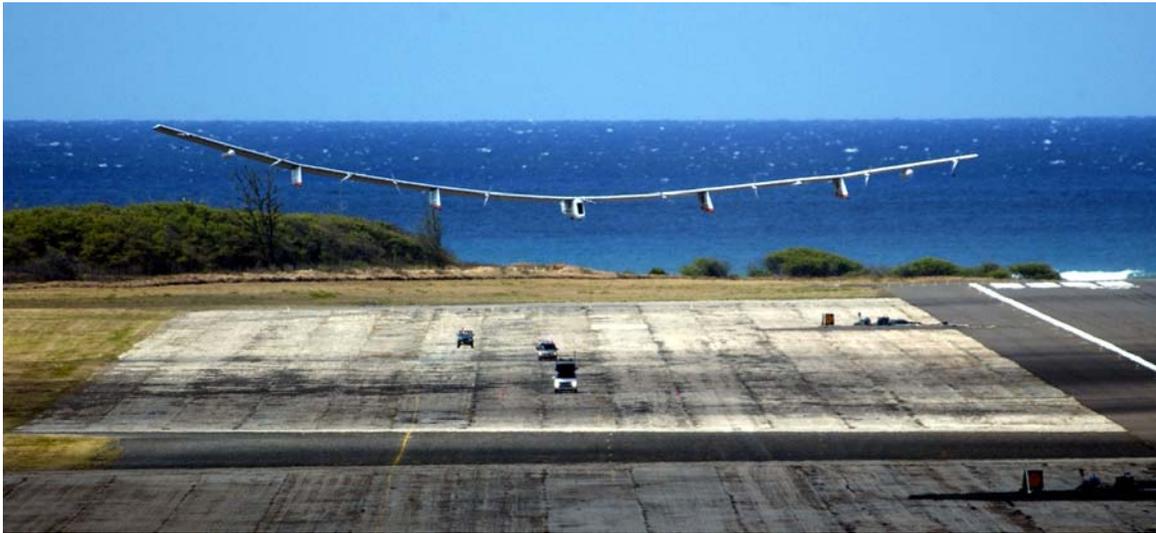
**Figure 7.2 - HP03-2 on Takeoff**

By 9:30am, a quantity ( $\sigma_w$ ) measured directly by the Sodar that is proportional to the strength of small-scale vertical velocity fluctuations and indicative of low-level turbulence risk, had increased from 0.4 m/sec to as high as 0.8 m/sec. Although these  $\sigma_w$  values did not violate mission rules of 1.0 m/sec, the Helios Meteorologist did advise the MFD that these values were the largest he’d seen for a takeoff, and high enough to expect light to moderate turbulence. After 9:38am, the  $\sigma_w$  value edged down to 0.7 m/s. In addition at 9:36am, the tower reported seeing white caps building offshore, indicative of the proximity of the shear lines. Whitecaps are clearly visible in Figure 7.2.

**Takeoff:** At 10:06am, about 1 1/2 hours later than planned, with winds at 7 knots from 300 degrees and scattered cumulus clouds, the MP throttled up to 50% (16 kW) for takeoff. Clouds were shadowing parts of the runway as the aircraft lifted off (Figure 7.2). The airplane headed out to sea as usual, however the climb rate was slightly less than normal due to cloud shadows.

- 8) At 9:36am, the tower reported that whitecaps were already visible offshore, indicative of the very close proximity of the southern shear line. Whitecaps are clearly visible in Figure 7.2.

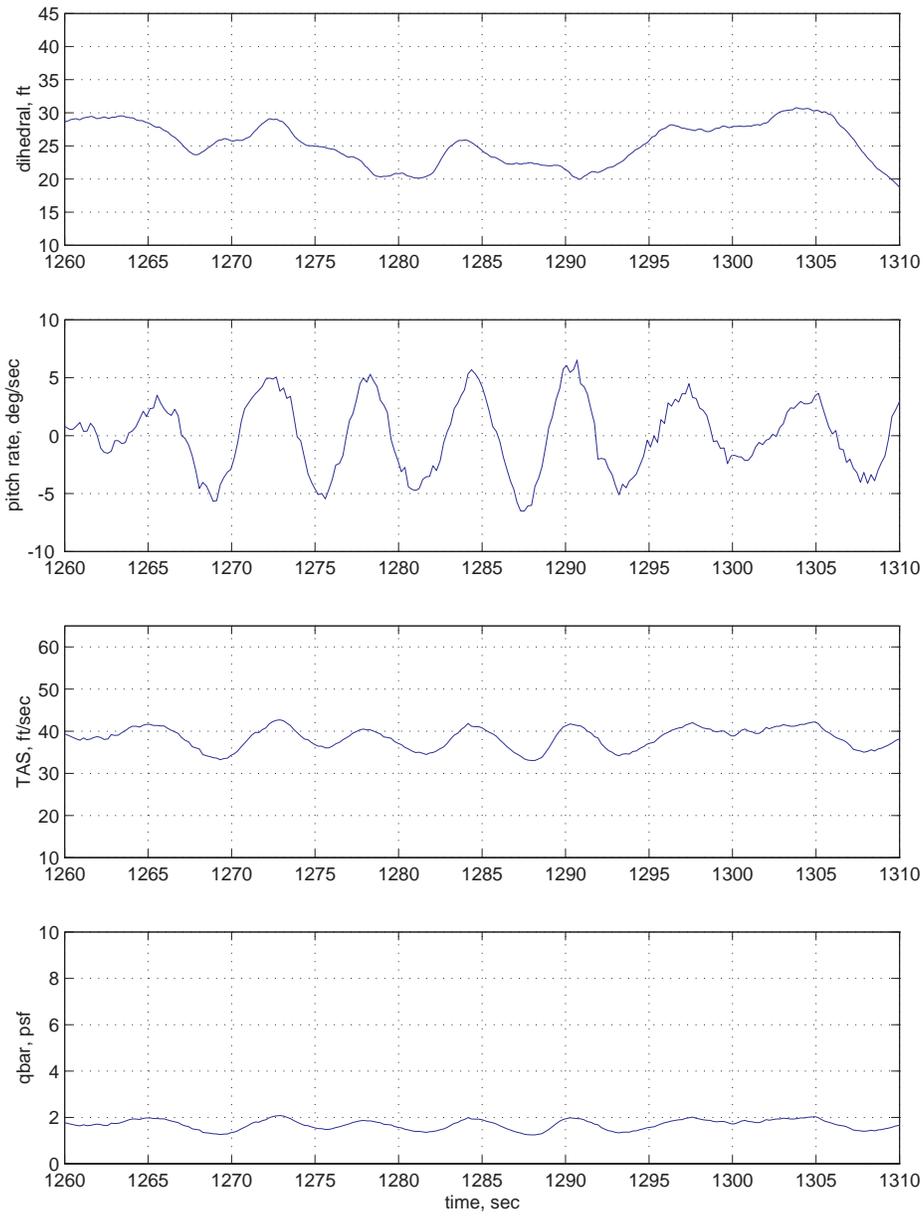
**Figure 9.7 - Dihedral, Pitch, Vehicle Airspeed, and Dynamic Pressure for Event 1**

The Matlab predictions, which included time delays determined during the flight test, agreed better with the flight observations. Although both models predicted more stability than observed in flight, they clearly capture the instability. The difference between predicted and observed neutral damping is not considered significant because the differences are about the same as the uncertainty of estimating wing tip deflection from strain gauge measurements. Clearly, the light to neutrally damped oscillations observed in an event 5 to 6 minutes before the crash corroborates these predictions. Figure 9.7 and Figure 9.8 graphically captures the damping estimates represented by two of the blue circles (first encounter or event involving the unstable mode and the mishap event) in Figure 9.6.
